**RELIABILITY IMPROVEMENT OF IOT-BASED SECURITY MONITORING DEVICES  
THROUGH INTEGRATED FAULT TREE ANALYSIS AND FAILURE MODE AND  
EFFECT ANALYSIS**

**Muhammad Ardiansa<sup>1</sup>, Franka Hendra<sup>2\*</sup>, Surasa<sup>3</sup>**<sup>1</sup> Department of Industrial Engineering, Universitas Pamulang, South Tangerang, IndonesiaCorresponding author: [dosen01508@unpam.ac.id](mailto:dosen01508@unpam.ac.id)**Abstract**

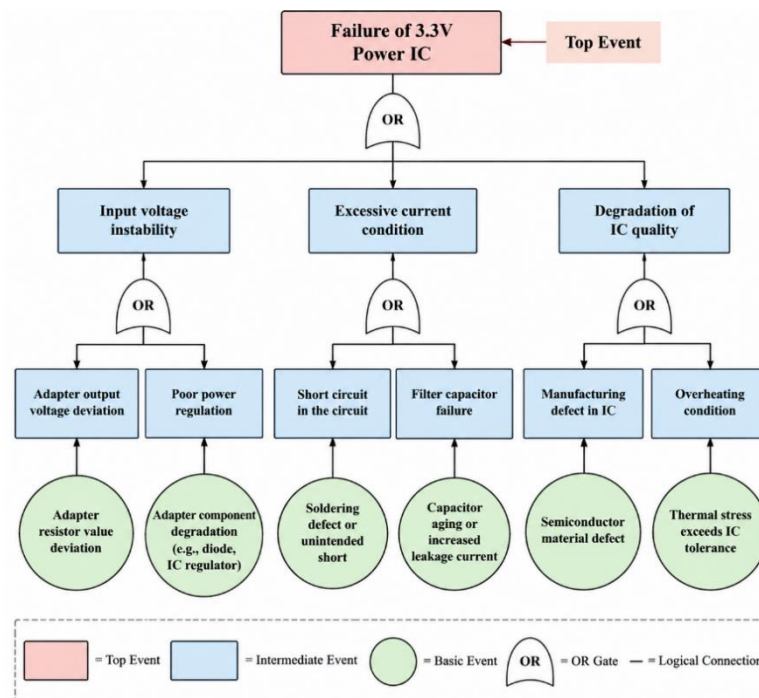
**Figure 2. Fault Tree Analysis of 3.3V Power IC damage**

The Fault Tree Analysis (FTA) results in Figure 2 show that the failure of the 3.3V Power IC is influenced by three main intermediate events, namely input voltage instability, excessive current conditions, and degradation of IC quality. These intermediate events are connected through an OR gate, indicating that the occurrence of one of these conditions can trigger failure of the 3.3V Power IC. The analysis further identifies several basic events that contribute to the failure mechanism, including adapter resistor value deviation, poor power regulation, short circuit conditions, filter capacitor degradation, semiconductor material defects, and thermal stress exceeding IC tolerance. Among these causes, semiconductor degradation and thermal-related stress represent critical factors because they can directly affect the internal structure and electrical performance of the IC. Therefore, the failure of the 3.3V Power IC is not only caused by a single component defect but results from the interaction between electrical instability, component degradation, and environmental operating conditions. The identified basic events from this FTA analysis are subsequently evaluated using FMEA to determine their risk priority based on severity, occurrence, and detection capability..

| No | Failure Mode Potential | Failure Effect | Failure Cause (Basic Event from FTA) | S | O | D | RPN |
|---|---|---|---|---|---|---|---|
| | | | Filter capacitor aging or increased leakage current causing loss of filtering capability | 8 | 8 | 7 | 448 |
| | | | Semiconductor material defect causing permanent IC silicon layer damage | 9 | 9 | 8 | 648 |

| N<br>o | What (What is the problem?) | Why (Why does it happen?) | Where (Where does it occur?) | When (When is the improvement implemented?) | Who (Who is responsible?) | How (How is the improvement performed?) |
|---|---|---|---|---|---|---|
| 1 | Adapter resistor value deviation causing 3.3V Power IC voltage instability | Resistor value changes due to component degradation, resulting in unstable voltage output supplied to the power IC | Adapter circuit / power supply section | During maintenance and component inspection | Maintenance Team | Replace the damaged adapter resistor with appropriate specifications and verify output voltage stability |

| N<br>o | What (What is the problem?) | Why (Why does it happen?) | Where (Where does it occur?) | When (When is the improvement implemented?) | Who (Who is responsible?) | How (How is the improvement performed?) |
|---|---|---|---|---|---|---|
| 3 | Permanent damage of IC silicon layer causing 3.3V Power IC failure | Semiconductor material degradation or internal IC damage prevents the IC from operating normally | 3.3V Power IC module on PCB | During device repair and failure replacement | Maintenance Team | Replace the damaged 3.3V Power IC and perform functional testing after replacement |

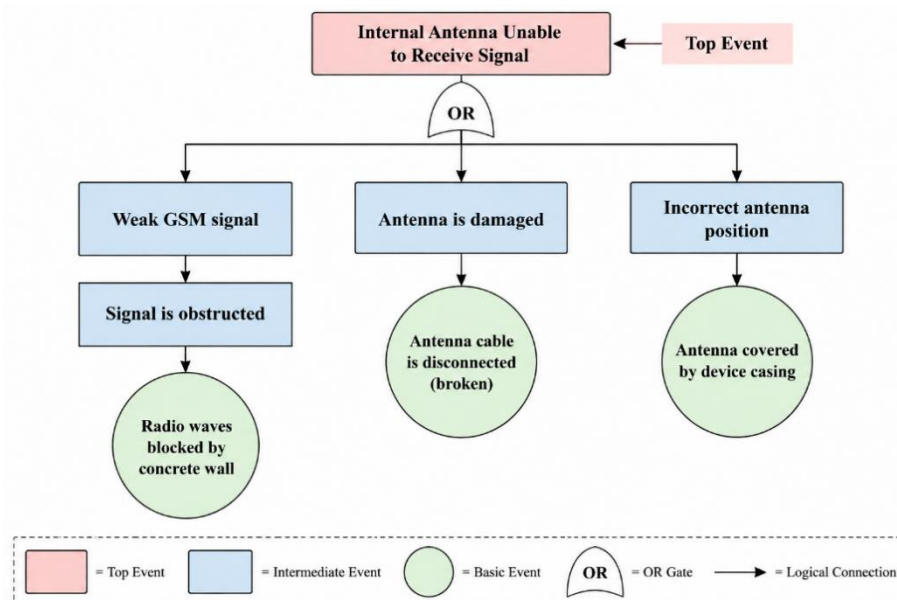
Figure 3. FTA Internal Antenna Not Capable of Reaching Signal

Furthermore, connectivity failure analysis was conducted on the internal antenna system, as presented in Figure 3. The FTA model identifies that the inability of the internal antenna to receive GSM signals is caused by three intermediate events: weak GSM signal conditions, antenna damage, and incorrect antenna positioning. These factors are connected using an OR gate, meaning that each condition has the potential to independently cause communication disruption. The basic events identified include radio wave obstruction caused by concrete walls, disconnected antenna cables, and antenna coverage by the device casing. These findings indicate that antenna performance is influenced not only by the physical condition of antenna components but also by installation conditions and the surrounding environment. Signal attenuation caused by obstacles and improper antenna placement can reduce communication quality, while physical damage to the antenna path can completely interrupt signal transmission. Therefore, improvement actions should consider both hardware inspection and optimization of device installation conditions..Next, the FTA diagram of the internal antenna is not able to reach the signal is shown in Figure 3.

| No | Failure Mode Potential | Failure Effect | Failure Cause (Basic Event from FTA) | S | O | D | RPN |
|---|---|---|---|---|---|---|---|
| 2 | Internal Antenna Unable to Receive GSM Signal | Communication failure between Alarm Node-PR22 device and monitoring center | Radio waves blocked by concrete wall causing weak GSM signal | 6 | 6 | 5 | 180 |
| | | | Antenna cable disconnected/broken causing antenna signal path failure | 8 | 8 | 8 | 512 |
| | | | Antenna covered by device casing causing incorrect antenna positioning | 5 | 7 | 6 | 210 |

| N<br>o | What (What is the problem?) | Why (Why does it happen?) | Where (Where does it occur?) | When (When is the improvement implemented?) | Who (Who is responsible?) | How (How is the improvement performed?) |
|---|---|---|---|---|---|---|
| 4 | GSM signal attenuation due to environmental obstruction | Concrete walls or physical obstacles weaken radio wave transmission and reduce signal quality | Device installation area | During signal disturbance occurrence | Technician | Relocate the device to an area with stronger GSM signal quality or optimize installation position |
| 5 | Internal antenna signal path failure | Antenna cable disconnection or damage interrupts signal transmission between antenna and communication module | Internal antenna connection path / PCB antenna track | During maintenance inspection | Maintenance Team | Repair the antenna connection by resoldering or replace damaged antenna cable/track |

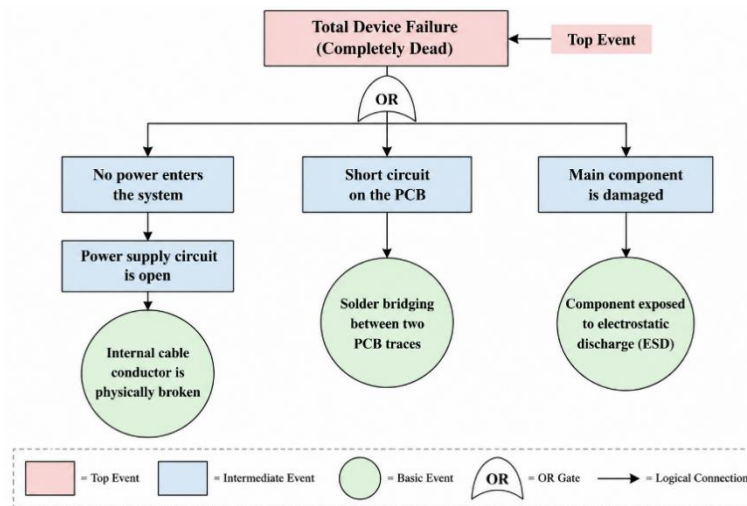
Figure 4. Fault Tree Analysis Device Totally Dead

The next FTA analysis focuses on total device failure, where the Alarm Node-PR22 device becomes completely unable to operate, as shown in Figure 4. The analysis reveals three possible failure pathways: loss of incoming power, PCB short circuit, and damage to the main electronic components. These pathways are connected through an OR gate, indicating that each failure mechanism can independently result in total device shutdown. The basic events identified include physical damage to internal cable conductors, solder bridging between PCB tracks, and electrostatic discharge (ESD) exposure affecting sensitive components. The results demonstrate that total device failure is strongly associated with hardware reliability issues during assembly, maintenance

activities, and operational conditions. In particular, PCB short circuits caused by improper soldering processes represent a significant risk because they may directly interrupt electrical continuity and damage other connected components..Next , the FTA *device diagram* total death is shown in Figure 4.

| No | Failure Mode Potential | Failure Effect | Failure Cause (Basic Event from FTA) | S | O | D | RPN |
|---|---|---|---|---|---|---|---|
| | | | Solder bridging between two PCB traces causing short circuit | 9 | 9 | 8 | 648 |

| N<br>o | What (What is the problem?) | Why (Why does it happen?) | Where (Where does it occur?) | When (When is the improvement implemented?) | Who (Who is responsible?) | How (How is the improvement performed?) |
|---|---|---|---|---|---|---|
| 7 | Internal cable conductor physically broken | Mechanical stress or aging causes physical separation of cable conductor | Device internal cable connection | During maintenance inspection | Technician | Replace damaged cable and ensure proper cable installation to prevent repeated failure |

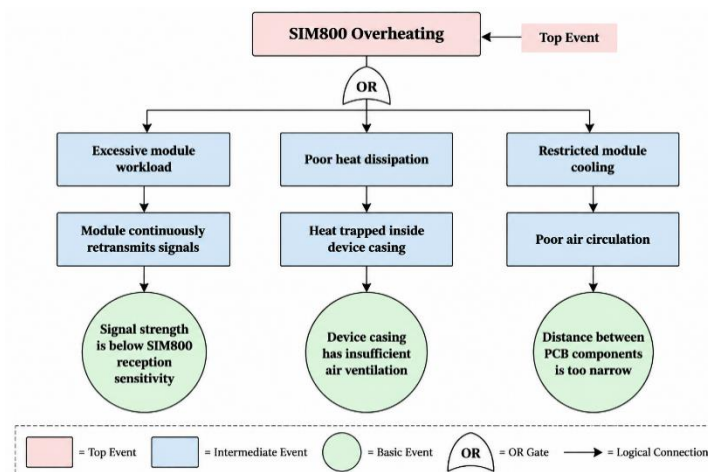
Figure 5. Fault Tree Analysis SIM800 Panas

The final FTA analysis evaluates overheating problems in the SIM800 communication module, as illustrated in Figure 5. The analysis identifies three intermediate events contributing to excessive temperature increase, namely excessive module workload, poor heat dissipation, and restricted cooling conditions. These events are connected through an OR gate, indicating that overheating may occur due to one or a combination of these conditions. The basic events include repeated signal retransmission caused by insufficient GSM signal strength, insufficient ventilation inside the device casing, and limited spacing between PCB components that restricts air circulation. The findings indicate that SIM800 overheating is related to both communication performance and thermal management design. Continuous retransmission increases module workload, while inadequate heat dissipation accelerates temperature accumulation inside the device. Therefore, reliability improvement requires not only communication optimization but also improvements in casing design and PCB thermal layout. Next , the Fault Tree Analysis Diagram of SIM800 Panas is shown in Figure 5.

| No | Failure Mode Potential | Failure Effect | Failure Cause (Basic Event from FTA) | S | O | D | RPN |
|---|---|---|---|---|---|---|---|
| 4 | SIM800 Module Overheating | SIM800 malfunction, communication instability, and possible module failure | Continuous signal retransmission due to weak signal strength below SIM800 sensitivity | 7 | 8 | 7 | 392 |
| | | | Device casing has insufficient ventilation causing heat accumulation inside module | 8 | 8 | 8 | 512 |
| | | | Narrow distance between PCB components restricting air circulation | 7 | 7 | 6 | 294 |

| N <sub>o</sub> | What (What is the problem?) | Why (Why does it happen?) | Where (Where does it occur?) | When (When is the improvement implemented?) | Who (Who is responsible?) | How (How is the improvement performed?) |
|---|---|---|---|---|---|---|
| 10 | SIM800 communication instability due to insufficient signal strength | Weak GSM network causes repeated signal retransmission and increases module workload | SIM800 communication module | During connectivity disturbance | Technician | Improve device location, optimize antenna position, and ensure sufficient GSM signal availability |

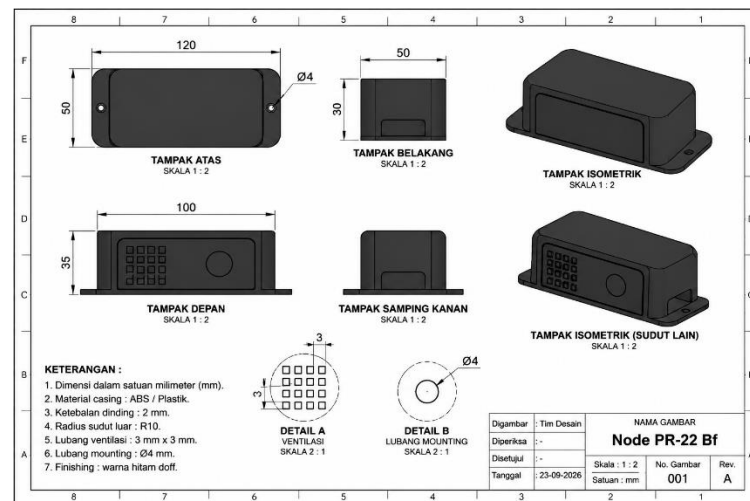
Figure 6. Before Casing

Based on the FMEA results, insufficient ventilation in the device casing was identified as one of the main causes contributing to SIM800 module overheating. The existing casing design has limited airflow, causing heat accumulation inside the device and reducing the reliability of electronic components during continuous operation. To overcome this problem, a casing redesign was proposed by adding ventilation openings to improve air circulation and enhance heat dissipation performance.

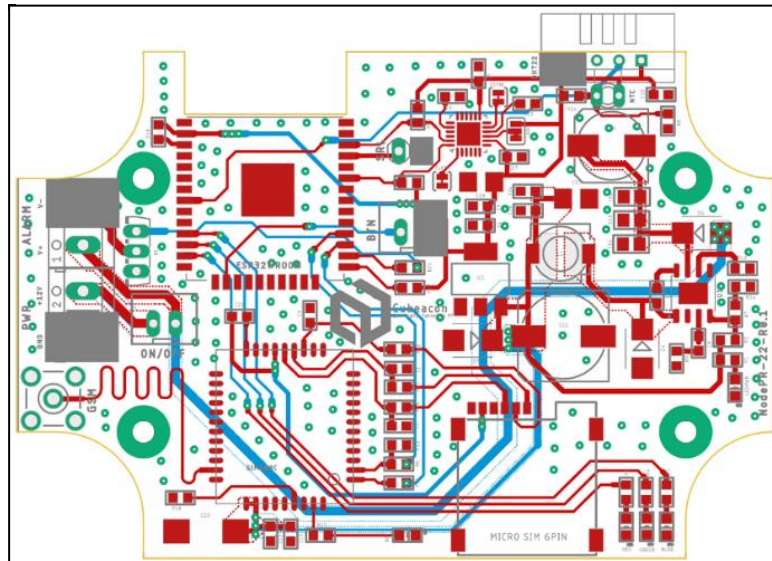
Figure 8. Before designing the PCB layout

Based on the FMEA analysis, one of the factors contributing to SIM800 module overheating is the limited distance between PCB components, which restricts airflow circulation and increases heat accumulation in the device. The existing PCB layout has a relatively dense component arrangement, causing heat generated by electronic components to accumulate in certain areas and reducing the effectiveness of thermal dissipation. This condition may affect component performance and decrease the long-term reliability of the Alarm Node-PR22 device.
